Test report No.: 22-00037-CP-PR-00
Manufacturer: OKB Sp. z o.o., Poland
Type: OB

Test of a type of a vehicle
with regard to ECE Regulation No. **14.00**
taking into consideration amendment No. **14.09, Supplement 1**
Approval subject: **Strength of safety belt anchorages**

Test of a type of a vehicle
with regard to ECE Regulation No. **17.00**
taking into consideration amendment No. **17.09, Supplement 1**
Approval subject: **Strength of seats and their anchorages and head restraints**

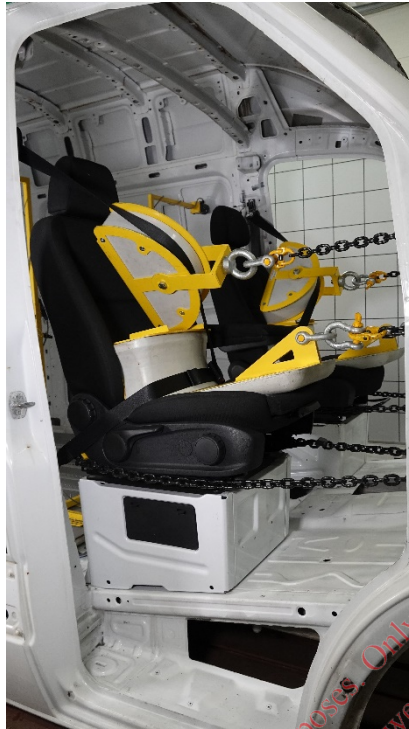
Pre-test:

3.4.3 MOBIFRAME type OB-S and OB-V in Mercedes Sprinter 906 and 907 bodywork.

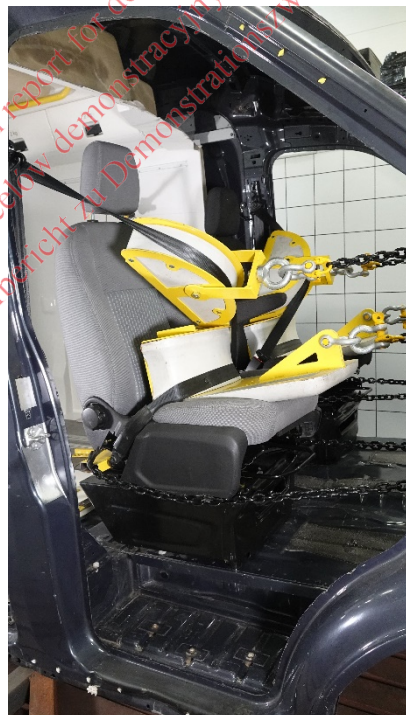
Pre-test:

3.4.4 MOBIFRAME type OB-T driver's and passenger's seats Ford Transit bodywork.

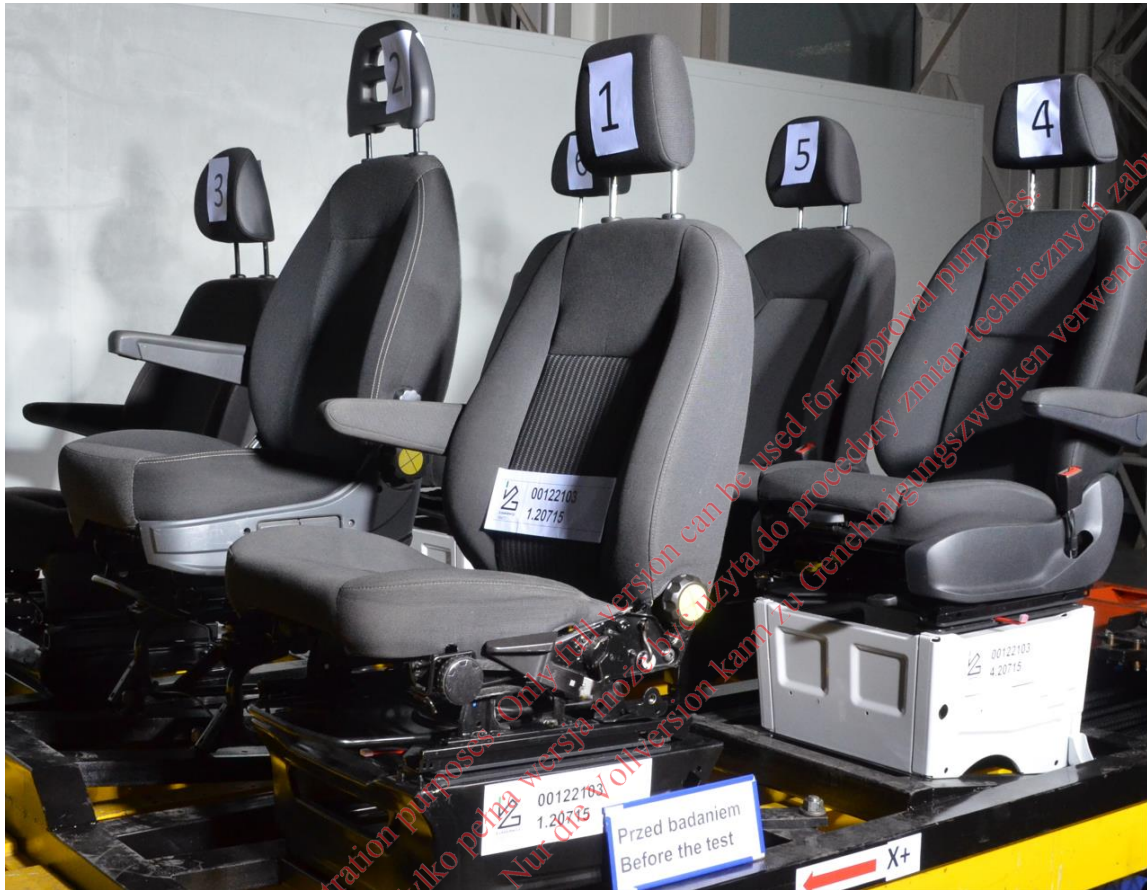
Photo of seats from point 3.3.3 – frontal impact
